<b>Observation Number:</b>	201903409
<b>Originator:</b>	
<b>Date Created:</b>	28-Feb-2019
<b>Business Unit:</b>	Projects
<b>Business Group:</b>	Conventional Energy
<b>Project/Office:</b>	Reading Office
<b>Sub Business Group:</b>	Europe & Africa
<b>Site/Office Name:</b>	Reading Office
<b>Work Related or Non-Work Related Observation?:</b>	Work Related
<b>Exact Location or Project of Act/Condition/Safe Behaviour:</b>	SP0E Corporate area
<b>Observation Type:</b>	Unsafe Condition
<b>Observer Name:</b>	Littleford, Mark
<b>Observer Email Address:</b>	mark.littleford@woodplc.com
<b>Stakeholder:</b>	Wood
<b>Observation Date:</b>	28-Feb-2019
<b>Observation Time:</b>	10:00
<b>Observation Close Date:</b>	
<b>Observation Category:</b>	Work Environment Pedestrian routes (floors, stairs etc.)
<b>Details of safety observation:</b>	the ramp is hidden by the carpet colour and local lighting, causing one of my colleagues to fall down the ramp, jarring his back.

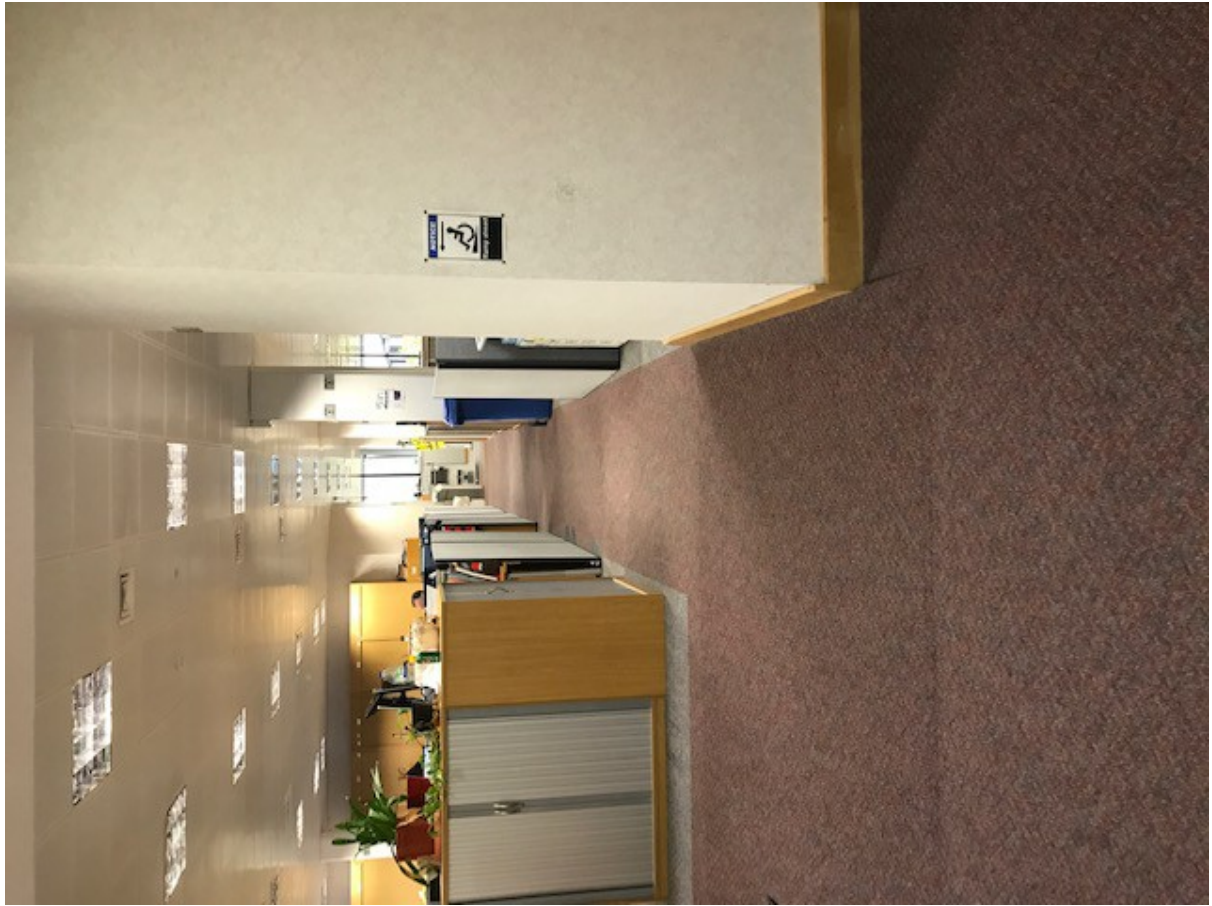
When entering the slope is visible and there is a warning sign.

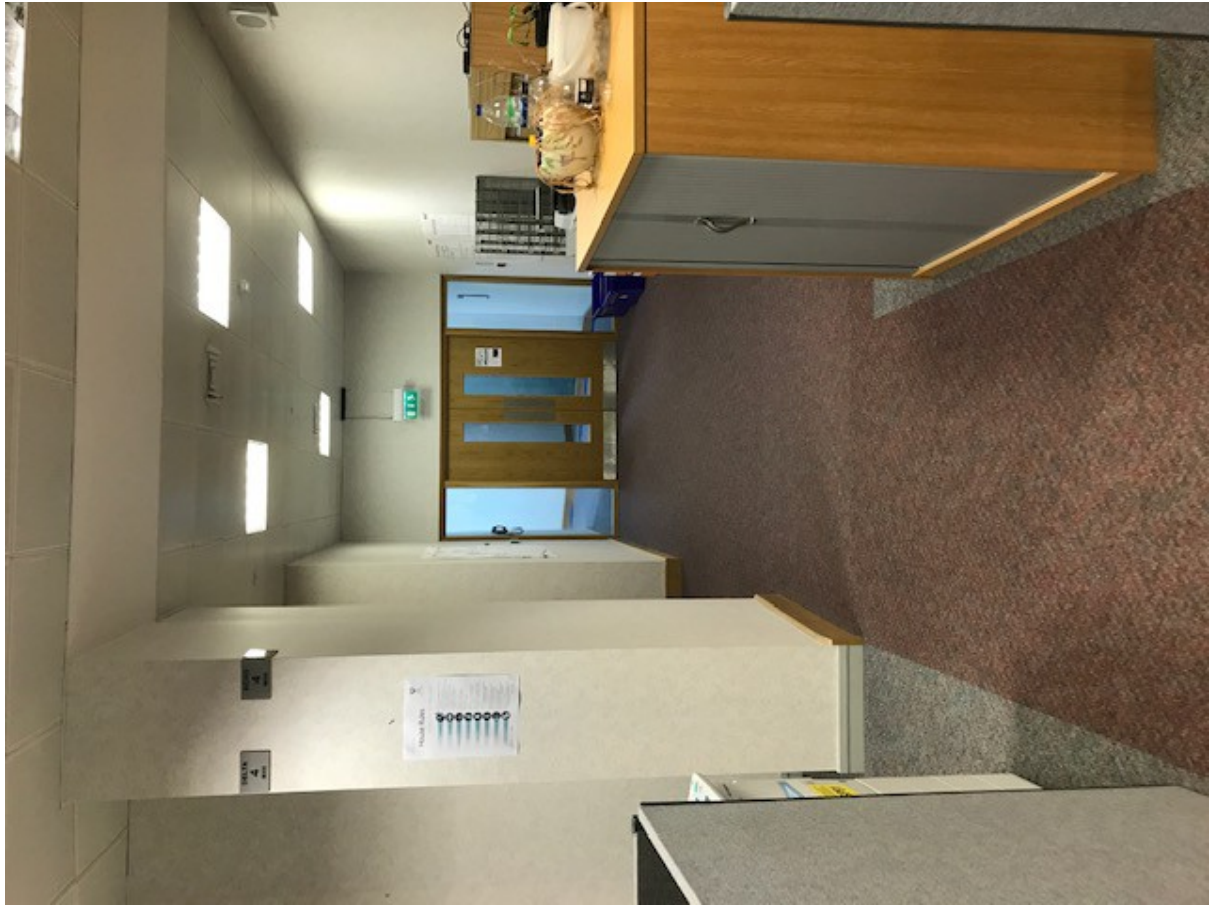
When leaving the office the ramp is hidden by lighting effect and there is no sign.
